# THERMAL METAL SPRAY: SUCCESSES, FAILURES AND LESSONS LEARNED

Willie L Mandeno

Opus International Consultants Ltd, Wellington, New Zealand

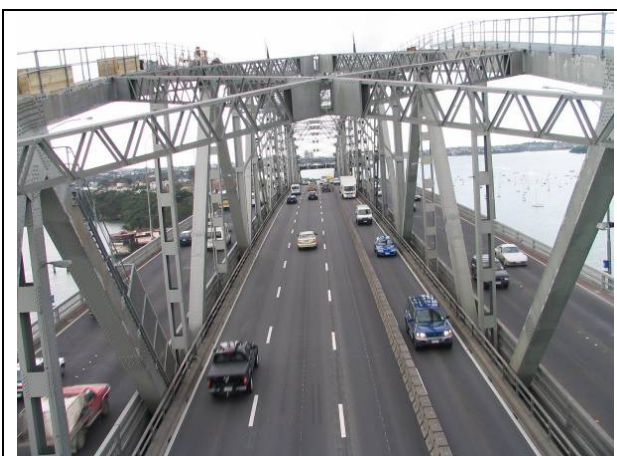
Figure 1. Auckland Harbour Bridge (1958)

The first major application was on the Auckland Harbour Bridge when in 1956 its coating specification was amended to the “best protective treatment known at the time”, i.e. flame sprayed with zinc at 50 microns and top coated with 3 coats of phenolic paint [25]. Another early and successful application was in 1960 to the roof trusses to the main grandstand at the Ellerslie racecourse in Auckland [4]. There have been many other applications of TSZ to steel items such oil piping, lighting columns, balcony supports; generally to components that could not be hot-dip galvanized.

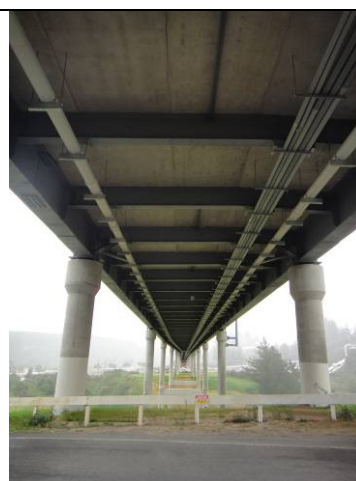
Figure 2. Wairakei Bridge (2010)

Recent applications have ranged from use of sealed TZA on wharf piles in Lyttleton and a highway bridge over geothermal steam pipelines at Wairakei. Sealed TSZ has been used to maintain in situ RSJ bridge beams over Ship Creek adjacent to a West Coast surf beach near Haast and also to coat new steel box girders on the Newlands Interchange Bridge in Wellington. Duplex systems (TSZ with epoxy/polyurethane topcoats) have also been applied to several new bridges including the replacement Kopu Bridge on State Highway 25 near Thames, the iconic Te Rewa Rewa Footbridge near New Plymouth, some smaller footbridges such as at Petone Railway Station, and seismic strengthening under the Thordon Over Bridges in Wellington. Some of these are pictured below and others that had problems are discussed in more detail in a later section.

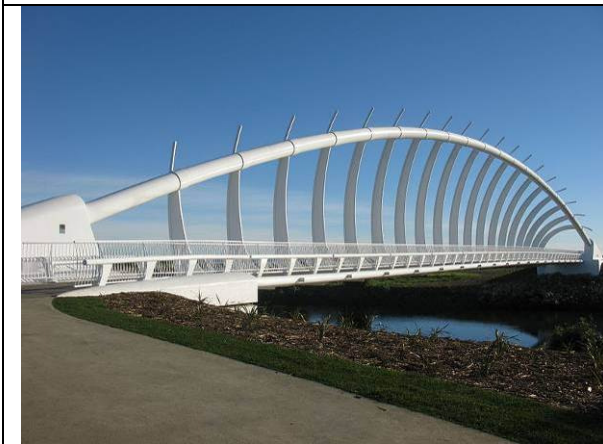
Figure 5. Te Rewa Rewa Footbridge (2010)

SINTEF reported that duplex TSZ had performed well on several road bridges in Norway where four coats of paint were applied over TZS100. A duplex TSZ system has been used successfully on New Zealand made air-bridges that have been supplied to several airports around Australasia (Figures 21 & 22). The future performance of the duplex coatings on the Te Rewa Rewa and Kopu bridges (Figures 5 & 6) will be monitored with some interest.

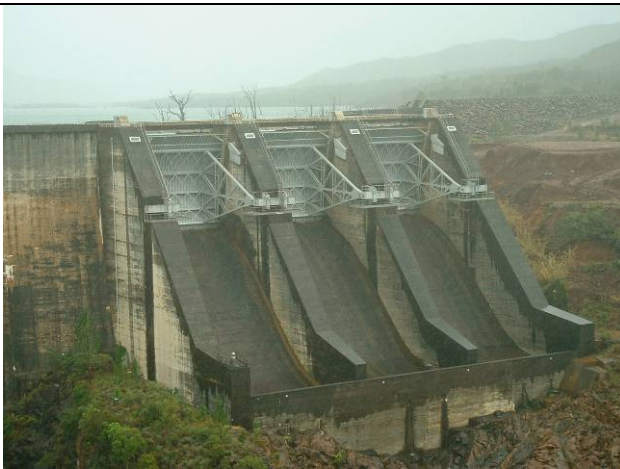
Figure 9. Late Dam gates, New Caledonia

Eleven tonnes of flame sprayed zinc powder was used in 1976 to coat the radial spillway gates on the Late Dam near Noumea in New Caledonia which are reported to still be in excellent condition, as are LPG spheres beside the harbour [28]. A TSA duplex system was recently used to coat a gas platform near East Timor but this suffered premature failure which is discussed later in this paper.

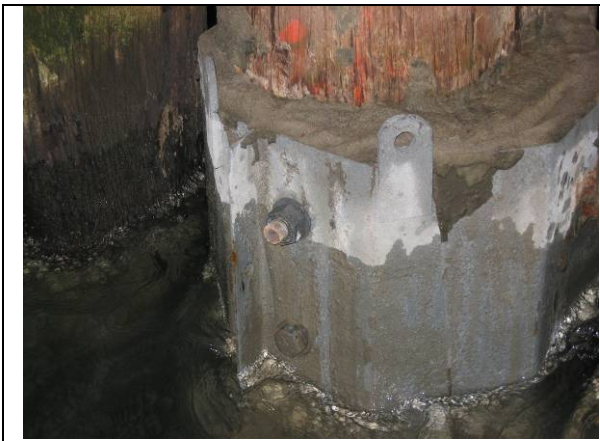
Figure 11. TSA on pile jacket

TSA has been used since 2005 to protect structural steel used as beams and jackets to strengthen old timber wharves owned by the Lyttleton Port Company (LPC) and this has performed well where correctly applied (Figure 11).

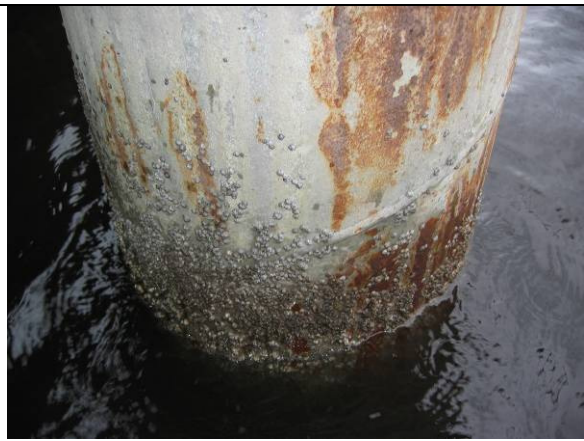
Figure 12. TSA “failure” on pile

In 2008 the author was asked to investigate premature failure of TSA coating on a new coal loading berth for the Lyttleton Port Company (LPC). As shown in Figure 12, the aluminium coating had been removed in the tidal zone on most of the piles; some were more severely affected than others. The piles were designed as bare steel protected with sacrificial anodes with a sealed TSA coating to protect them above the low tide level. Inspection by divers found that the installed anodes were undersized for the area they were required to protect and some had become disconnected during driving. The TSA was therefore acting as a sacrificial anode and had to be replaced by a petrolatum wrap and HDPE jacket, plus bigger capacity anodes were retrofitted to the piles to protect the uncoated surfaces.

TSZ and TZA will provide cathodic protection (CP) to small coating defects and will protect small bare areas. However when used on structures that are immersed in seawater, their life as a barrier coating will be significantly reduced when connected to large areas of bare steel (or more cathodic metals) which must have a correctly designed and installed CP system to protect them, and also to ensure the TSM remains at a passive potential.

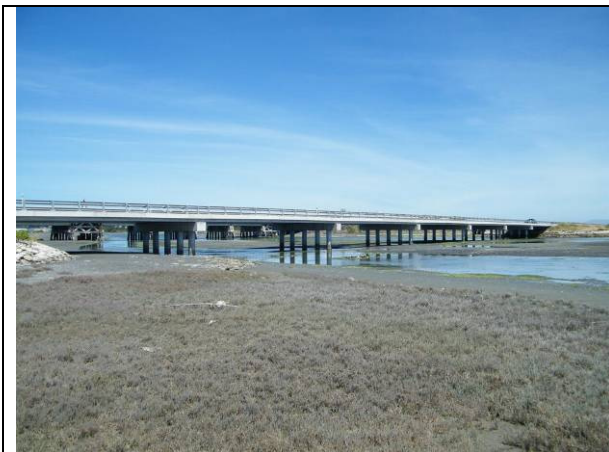
Figure 13. Ahuriri Bypass

An expressway near Napier Airport includes a bridge structure over the Ahuriri Lagoon. The steel jackets to its concrete piles were coated with TSA325 in 2003. A few years later roughly circular rust patches approx 100 to 200mm in diameter appeared in random locations below high tide level as shown in Figure 14. Its failure is currently under investigation with unsuitable repair methods (patching areas of low build with UHB epoxy) being suspected as being responsible.

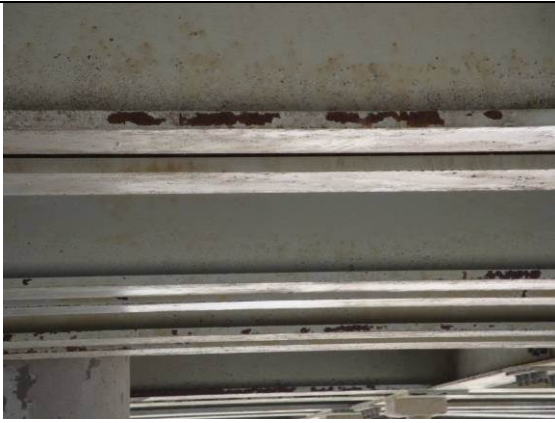
Figure 15. Duplex TSZ failure on catch frame

The seal coating is delaminating from the upper levels of the pier jackets where windborne marine salts are not removed by rain washing (Figure 16) but no corrosion has been observed. However red rusting has occurred on the catch frame steelwork which is currently being recoated but with an additional 200 micron epoxy intermediate coat added to the system over an epoxy zinc patch primer. The corrosion is due to delamination of the duplex TSZ from flange edges of the fabricated I-beams and also pitting corrosion where peaks of the zinc had inadequate barrier protection from the epoxy urethane (Figure 15).

Overcoated TSZ in seawater forms zinc chloride which is relatively stable, soluble and does not acidify the electrolyte. However when any zinc protective coating is overcoated with an organic coating, its ability to self-protect itself and any breaks in the coating with a large anodic surface is correspondingly reduced. This applies to TSZ just as it does to galvanized steel and inorganic zinc silicate coatings. Where these zinc coatings need to be coated for chemical or abrasion resistance, or to change their colour for safety or aesthetic reasons, it is important that a continuous and low permeability coating is applied of sufficient thickness to provide an effective barrier to corrodent materials, especially where these are not removed by rain washing.

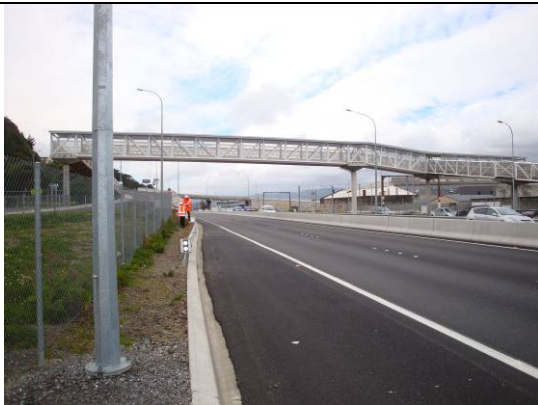
Figure 17. Petone Footbridge

This structure, located 600m from the Wellington Harbour, was coated with a duplex TSZ system in 2010 but required patch painting within two years. The specified system was 175 microns of TSZ, sealed with 50 microns of epoxy and topcoated with 75 microns of polyurethane. Premature failure occurred in areas where the peaks of the coarse surface profile of the TSZ had not been smoothed as required by the specification and so were close to the top surface of the paint on surfaces that were sheltered from rain washing.

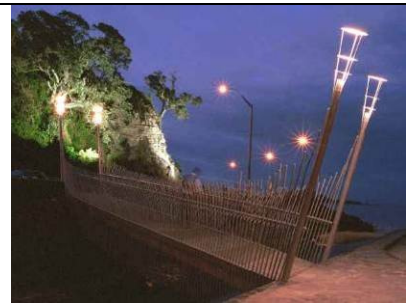
Figure 19. Millenium Footbridge

Built as part of a waterfront walkway near Mission Bay, Auckland in 2001, the steelwork that was designed by artist Virginia King, was coated with TSZ. GANZ has reported [29] that this failed prematurely and in 2009 the flaking TSZ was removed and replaced with a duplex galvanizing system at a cost of \$70,000.
